KRZYSZTOF DYDUCH\*, RAFAŁ SZYDŁOWSKI\*\*

## MATERIAL-CONSTRUCTION SOLUTIONS APPLIED IN LONG-TERM REPAIRS OF REINFORCED GRANULATION TOWERS IN NITROGEN PLANTS

DOI: 10.4467/2353737XCT.15.161.4336

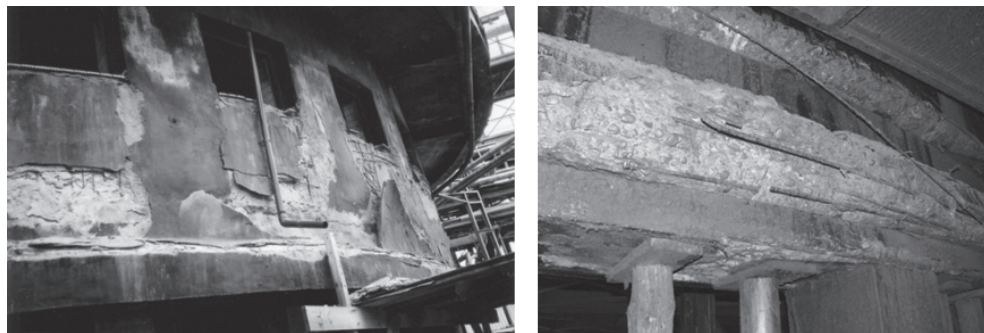
In 2002, after fifty years of operation in the aggressive environment of the plant, the towers were subjected to advanced degradation as a result of the ammonium and sulphate corrosion of the concrete. The monolithic foundation of the tower (Fig. 3) as well as the prefabricated

cylindrical shell (Fig. 4) were seriously destroyed. Losses of concrete in the prefabricated wall reached two-thirds of the wall thickness. Additionally, there was considerable local damage to the cross-section of the vertical ribs. In the lower monolithic part of the tower, the concrete cover of the cylindrical walls, columns and tie beams were damaged. Almost completely corroded reinforcing bars were localized.

Fig. 3. Corrosion of monolithic foundation of the tower in 2002

It was recommended to remove the concrete cover from reinforced concrete foundation columns and to protect these columns with a 5–7 cm thick reinforced layer. Additionally, the concreting of the monolithic ring wall from the outside was designed to be at a level of +3.00 to +6.00 m with 15 cm thick concrete reinforced with two meshes  $\phi$  8 every 150 mm on both surfaces and anchored to the original wall with  $\phi$  12 mm anchors spaced at  $300 \times 300$  mm.

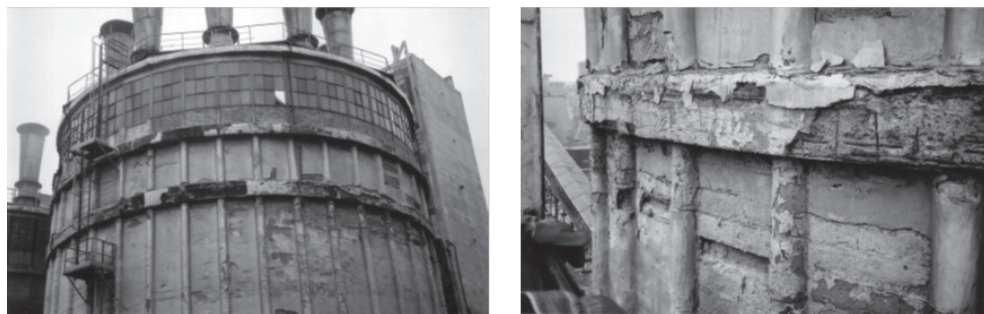
Fig. 4. Corrosion of the prefabricated cylindrical shell (2002)

In 2002, ad hoc repairs were made and tower number 2 was strengthened with the intention of its further operation for a period of 5 years. It was presented by Dyduch, Płachecki et al. [1]. For the reprofiling of the damaged concrete elements (surface of the prefabricated shell of the tower, tie beams and monolithic foundation elements), class B25 mortar was recommended (or concrete in the case of more extensive damage) to be used on CEM-II/A-D silica Portland cement with the addition of high-quality plastic dispersion – this was based on a styrene-butadiene from a reputable supplier of construction chemicals and designed to improve repair screeds and make a bonding layer. On the basis of that dispersion, it was also recommended to use the bonding layer.

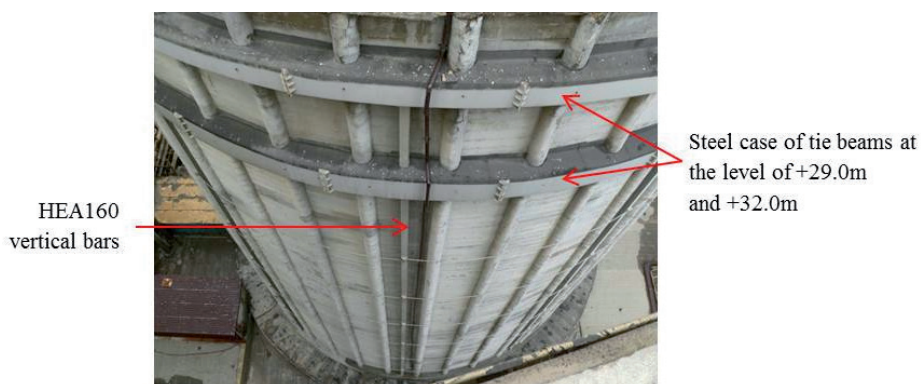
Fig. 5. Steel reinforcement of the granulation tower

The reinforcement of the tie beams at a level of +29.12 and +31.83 m were designed in the form of steel casing as well as additional 10 HEA 160 vertical bars extending from a level of +6.0 to +29.12 m and anchored to the prefabricated cylindrical wall (Fig. 5). The role of the designed reinforcement was to safely transfer the loads from the top of the tower (technological ceiling, flat roof and reinforced concrete upward extension) and relieve the prefabricated coating.

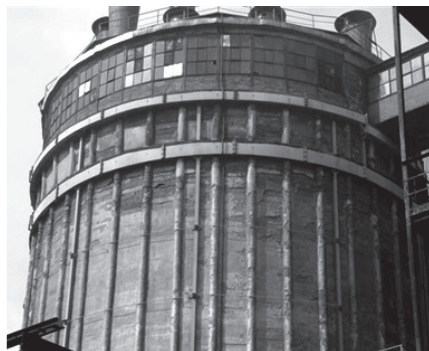
The tower had again degraded 4 years after its repair. The precast coating reinforced concrete elements (Fig. 6a) were significantly damaged. The concreting of the pillars of the foundation was seriously cracked and loose. One of the reasons for the damage was certainly the contractor's breach of technological regimes contained in the project and instructions for the use of materials for re-profiling. Undoubtedly, the main reason for the damage was contaminated concrete and the aggressive environment around the towers – this was caused

Fig. 6. a) damage of prefabricated shell elements four years after repair; b) exhaust chimney near the tower

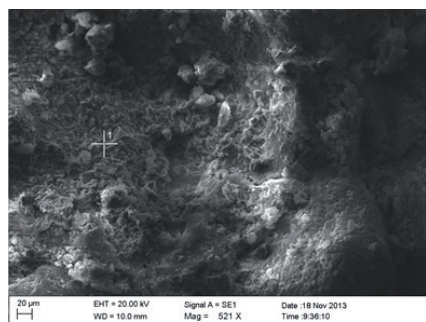
with chloride corrosion. In the considered period of seven years, a significant increase in  $\text{SO}_4^{2-}$  ions was identified – this proves the progressive corrosion of sulphate. The ion content, as compared to the weight of the binder in 2007, amounted to 2.5% in all three tested samples. Meanwhile, in the samples taken in 2013, that value ranged from 3.5 to 5.0 (with an average value of 4.38). Figure 7 presents the results of observation in the scanning electron microscope for one of the samples taken in 2013. The results present a leaky structure formed by the processes of dissolution and sulfate corrosion (Fig. 7a), as well as its confirmation in EDS analysis (ettringite formation – Fig. 7b).

Fig. 7. The results of the observation of the concrete sample in the scanning electron microscope: a) leaky structure formed by the processes of dissolution and sulfate corrosion; b) EDS analysis results (ettringite formation)

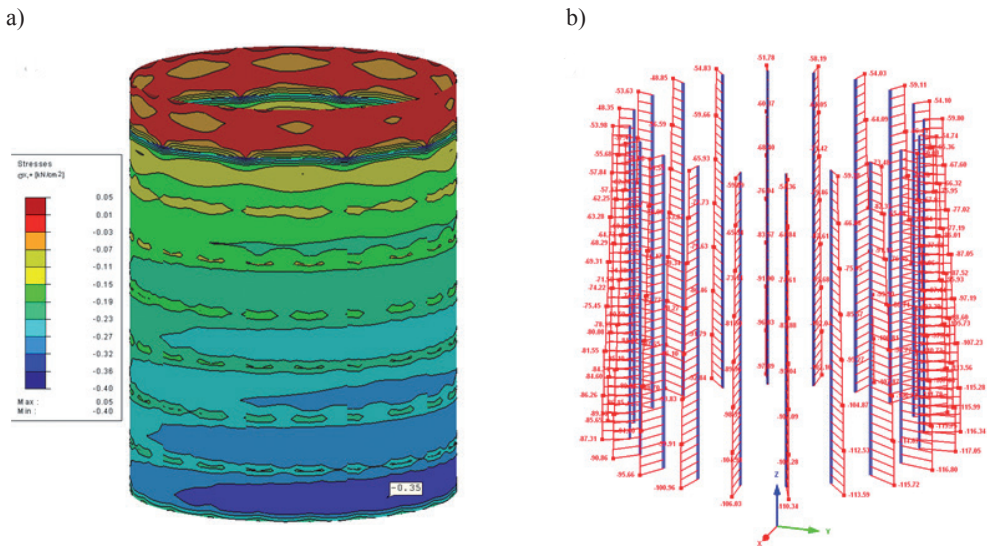
Fig. 8. The results of static analysis of the structure for Option 1: a) concrete shell vertical compression [kg/cm<sup>2</sup>]; b) steel pillar forces [kN]

slabs of the coating amounted to 3.5 MPa for Option 1 and 1.9 MPa for Option 2. Forces in the steel pillars amount to 117.1 and 65.0 kN, which generate compression in the steel sections equal to 30.2 and 16.8 MPa.

The conducted analysis of stress indicates a high level of compression in the concrete slabs (3.5 MPa) in Option 1. Given a dramatically low technical condition of the concrete, the loss of even half of thickness of the coating resulting the concrete stress increase can be considered. As a result, the compressive stresses can cause a loss in the stability of the reinforced concrete cylindrical shell and losses of concrete fragments.

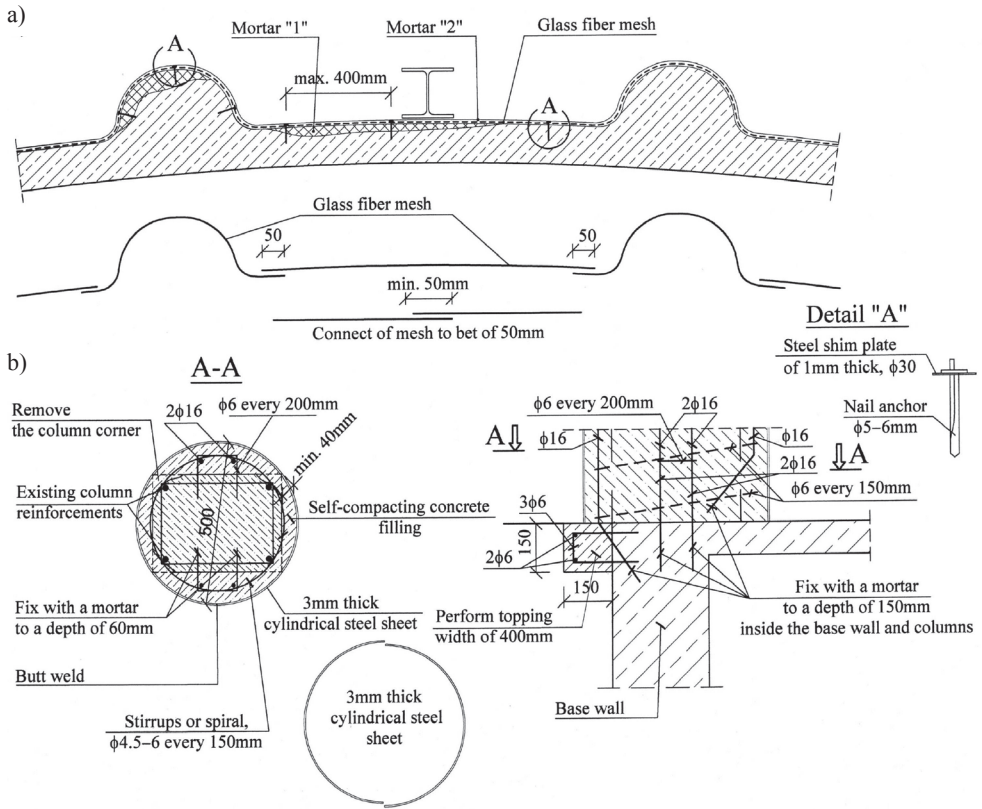
Fig. 9. a) details of protection of prefabricated concrete shell; b) reinforcement of foundation columns

Because of a high level of concrete stress, a low durability of previously conducted repairs and a long period of the planned operation of towers had to be used a good protection. The effectiveness of repairs to deeply damaged concrete elements depends on the bonding of the applied repair layer with a concrete base. For this reason, bonding layers are applied according to the 'wet on wet' principle, i.e. after the application of the bonding layer, prior to its bonding and drying, the surface should be repaired. This technological requirement hinders the execution of repairs. Defective execution of repairs decreases their efficiency and durability. Additionally, the effectiveness of repairs is worsened by the low strength and chemical contamination of concrete. In order to ensure long-term protection of the elements of the tower in a contaminated environment, it was necessary to find a more effective solution than the solution used previously. Among other proposals, the possibility of making an outer coating, made of stainless steel, was considered. Finally, the system of a reputable supplier of construction chemistry, not requiring the use of an additional bonding layer, was applied. After the removal of the corroded concrete particles and thorough cleaning of the concrete surface and reinforcing steel, it was recommended that the extensive loss of concrete be replaced with fine-grained, thixotropic repair mortar with controlled shrinkage, reinforced by synthetic fibers with an average compressive strength of 30 MPa (Fig. 9a – mortar '1'). The mortar is usually applied in layers with thicknesses of up to 25 mm. After the re-profiling of concrete cavities, the reinforced protective coating of 5–6 mm was applied all over the surface of the prefabricated wall. For this purpose, a two-component cement mortar with high strength and plasticity dedicated to strengthening of masonry structure (mortar "2") was used. This mortar includes fine aggregate, special additives and an aqueous dispersion of synthetic polymers. Due to the high content of synthetic resin, it forms a stable and durable layer which is impermeable to water and the aggressive components present in the atmosphere, and it is not a barrier to water vapour diffusion. The protective layer was reinforced with an alkali-resistant glass fibre mesh with meshes of 25 × 25 mm and a weight of 225 g/m<sup>2</sup>, tensile strength of 45 kN/m and strain at rupture of less than 3%. Given the poor adhesion of the protective coating applied to the corroded concrete, the anchoring to the original wall of the tower was applied with the support of nail anchors spaced at not more than 400 mm in both directions.

Reinforced concrete foundation columns were encased in a 3mm thick steel layer (Fig. 9b) after all loose and cracked concrete parts were forged together. After prior reinforcement of concrete filling of a steel casing in accordance with Fig. 9b (4mm vertical bars  $\phi$  16, pasted into the parent concrete, transverse stirrups and pasted bonding inserts), the inside of the casing was flooded with self-compacting concrete.

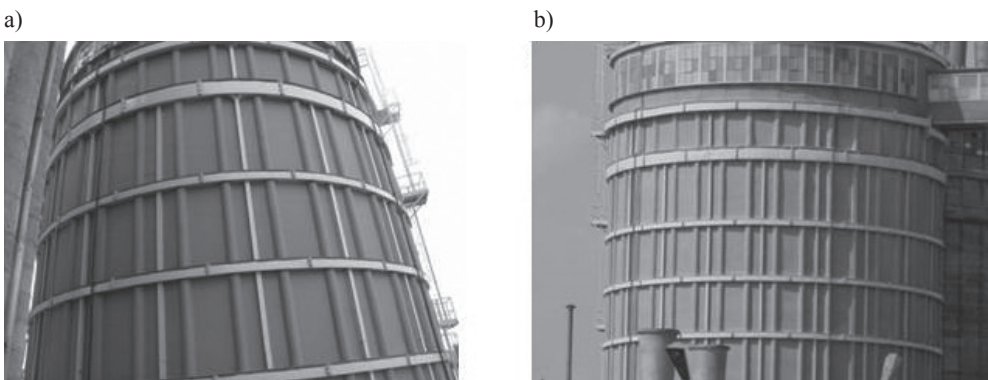
Fig. 10. a) the granulation tower shortly after renovation (mid-2012); b) the same tower after 2.5 years of operation

of vertical HEA 160 steel posts was increased from 10 to 20 during the previous repair. Moreover, 6 reinforced peripheral tie beams with cross-sections of  $300 \times 300$  mm, evenly spaced at 3.2 m, were designed. The tie beams were made from steel formwork (Fig. 10), armed longitudinally and transversely, and combined with the concrete wall.
