KRZYSZTOF DYDUCH\*, RAFAŁ SZYDŁOWSKI\*\*

## MATERIAL-CONSTRUCTION SOLUTIONS APPLIED IN LONG-TERM REPAIRS OF REINFORCED GRANULATION TOWERS IN NITROGEN PLANTS

DOI: 10.4467/2353737XCT.15.161.4336

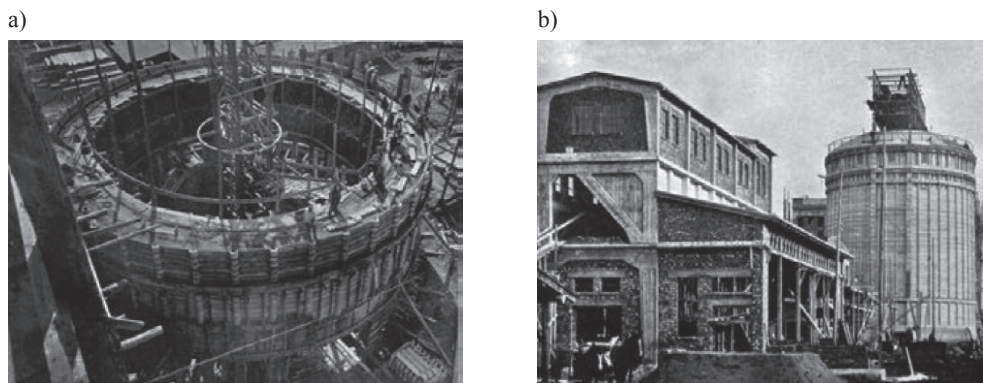
Fig. 1. a) One of the granulation towers during construction; b) A view of one of the towers from the nineteen-thirties

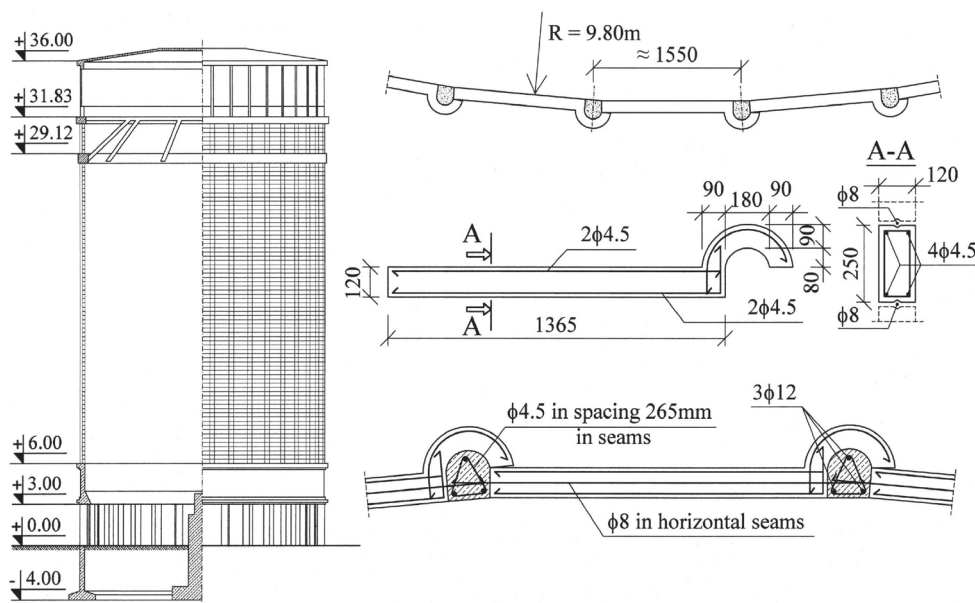
The structure of the tower is mixed (Fig. 2). The foundation up to a level of +6.00 m is formed by a reinforced concrete monolithic structure with a height of 3.0 m supported by columns. The main part of the cylindrical shell between the levels of +6.00 and +32.00 m

Fig. 2. Geometry and structural details of the granulation towers
